## Urgent Field Safety Notice

<b>Commercial name of the affected product:</b>	Keeler Wall-plug Power Supply
<b>Part number:</b>	EP29-32777
<b>Scope:</b>	This FSN will only affect Keeler product shipped prior to 1/1/2006
<b>FSCA identifier:</b>	CAPA 1096
<b>MHRA references:</b>	<b>2015/001/012/601/005 &amp; 2015/001/014/081/004</b>
<b>Type of action:</b>	Advisory Notice
<b>Date:</b>	10/2/2015 – issue 1
<b>Attention:</b>	Distributors and Users
<b>Transmission of this Field Safety Notice:</b>	This notice must be passed on to all those who need to be aware within your organisation; This must include: <b>Quality/Regulatory, Theatre, Maintenance</b>

This notice only applies to Wall-plug Power Supplies shipped prior to: **Jan 01 2006 and marked “MADE IN TAIWAN R.O.C.”**

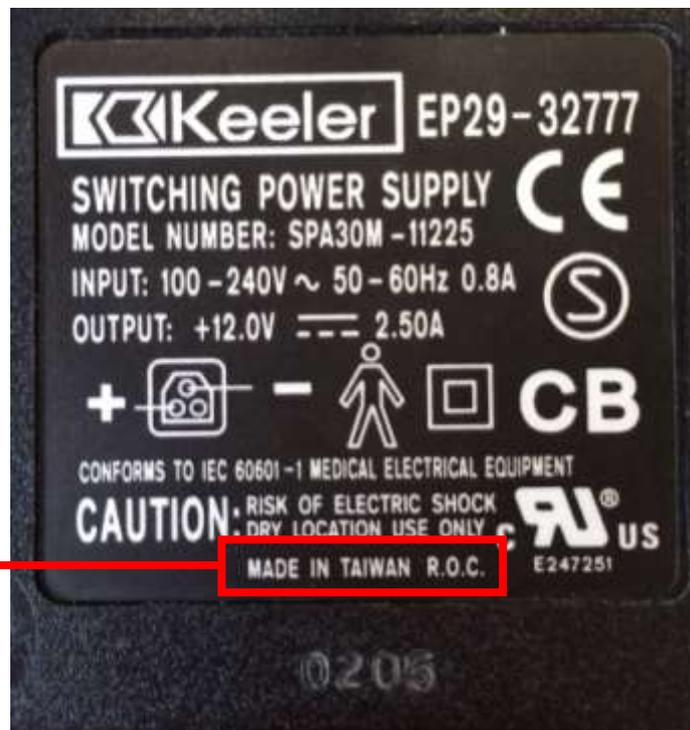
The Wall-plug Power supplies concerned carry a label as shown below and only those with identical labels and with the marking **“MADE IN TAIWAN R.O.C.”** are of concern to this notice.

Following investigations we believe that excessive impact or repetitive external knocks to the housing of the Wall-plug can lead to degradation of the internal insulation protection and/or sudden development of a hazardous electrical fault in the power supply. When subjected to physical damage some Wall-plugs can be rendered unsafe and pose a potential risk of electric shock.

- i) Check the label on the reverse side of the wall-plug. Only power supplies with an identical label to the above and with the marking "MADE IN TAIWAN" are of concern.
- ii) Check the physical appearance of the housing for any sign of damage, scratches, etc. The housing is of strong plastic type so even slight signs of damage are undesirable and would require replacement of the power supply.
- iii) Ensure that your test engineers carry out their regular Electrical Appliance safety tests. Replace the power supply if it fails the Isolation Resistance test.

If you are concerned that your unit may be affected, please speak to your local Keeler representative to discuss replacing it. Investigations have confirmed that only power supplies marked with “**MADE IN TAIWAN R.O.C.**” are affected. You can contact Keeler directly:
